# GE Fanuc IC695CMU310

## IC695CMU310

### Max-ON Hot-Standby Redundancy CPU

GFK-2420H  
May 19, 2008

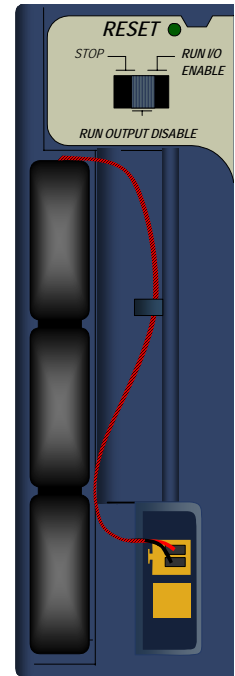
A three-cell lithium battery pack (IC698ACC701) maintains data memory when power is removed and operates the calendar clock. For maximum battery life, do not connect the battery for the first time until the CPU is installed in the backplane and the backplane is powered on. The battery may then be attached to either of the two terminals in the battery compartment as shown at right. Program and initial values load from flash when the CPU powers up. When replacing the battery, be sure to install a new battery before disconnecting the old one. If a new battery is installed when no battery is currently installed, the new battery must be installed while the CPU has power. Otherwise, the CPU may not power up. If that happens. Remove the battery, power-cycle the CPU, then reinstall the battery.

To avoid loss of RAM memory contents, maintenance procedures should include scheduled replacement of the battery pack. For information on estimating battery life, refer to the *PACSystems CPU Reference Manual*, GFK-2222. **Disposal of lithium batteries must be done in accordance with federal, state, and local regulations.** Be sure to consult with the appropriate regulatory agencies before disposing of batteries.
