PACSystems* RX3i IC695NIU001 PLUS

Ethernet Network Interface Unit

GFK-2598
March 2011

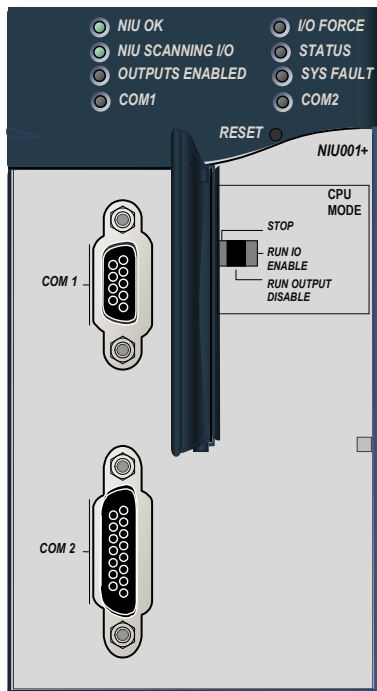
Front View

NIU Plus Battery and Switch Locations

The Ethernet NIU Plus has two switches. The Reset switch is not used. The three-position Run/Stop switch is located behind the protective door, as shown above.
