GE Fanuc IC695CRU320

Rx3i PacSystem

IC695CPU320/CRU320 Models

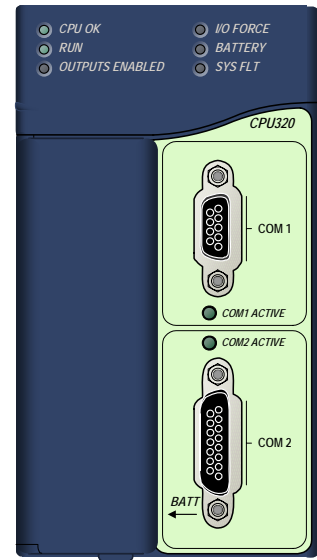
The eight CPU LEDs indicate the operating status of various CPU functions.

LED State			CPU Operating State
● On	✚ Blinking	○ Off	
●	CPU OK	On	CPU has passed its powerup diagnostics and is functioning properly.*
○	CPU OK	Off	CPU problem. RUN and OUTPUTS ENABLED LEDs may be blinking in an error code pattern, which can be used by technical support for troubleshooting. This condition and any error codes should be reported to your technical support representative.
✚	CPU OK, OUTPUTS ENABLED, RUN	Blinking in unison	CPU is in boot mode and is waiting for a firmware update through a serial port.
✚	OK	Blinking Other LEDs off.	CPU in Stop/Halt state; possible watchdog timer fault. Refer to the fault tables. If the programmer cannot connect, cycle power with battery attached and refer to fault tables.
○	RUN	Off	CPU is in Stop mode.
●	OUTPUTS ENABLED	On	Output scan is enabled.
○	OUTPUTS ENABLED	Off	Output scan is disabled.
●	I/O FORCE	On	Override is active on a bit reference.
●	BATTERY	On	Battery has failed or is not attached. Note: To provide reliable backup, routine maintenance should include scheduled battery replacement. See "Specifications" on page 2-15.

●	SYSTEM FAULT	On	CPU is in Stop/Faulted mode because a fatal fault has occurred.
✚	COM1 COM2	Blinking Blinking	Signal activity on port.
