GE Fanuc IC695NKT001

PACSystems* RX3i IC695NIU001 PLUS

Ethernet Network Interface Unit

GFK-2598
March 2011

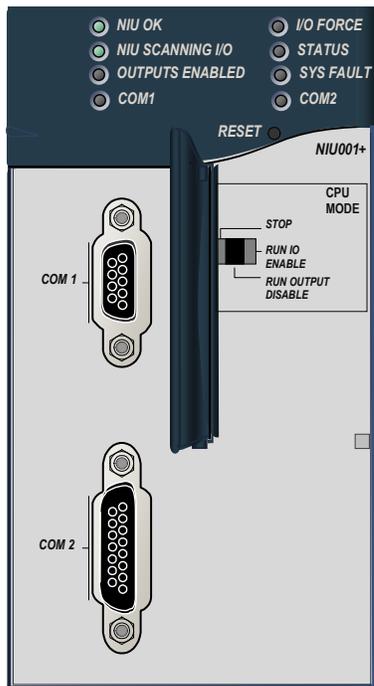
Front View

NIU Plus Battery and Switch Locations

The Ethernet NIU Plus has two switches. The Reset switch is not used. The three-position Run/Stop switch is located behind the protective door, as shown above.

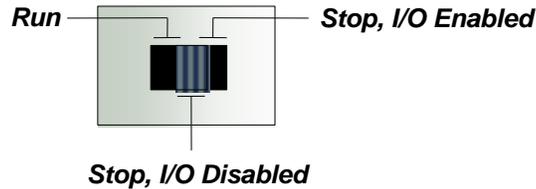
Unlike the Run/Stop switch on a CPU module, on an Ethernet NIU the use of this switch is disabled by default. If the switch is to be used to control the Run or Stop mode operation of the NIU, clear faults, and/or prevent writing to program memory or configuration, it must be enabled on the Settings Tab of the Ethernet NIU configuration in the folder, and stored to the ENIU.
